**PRELIMINARY ASSESSMENT/
VISUAL SITE INSPECTION**

**NAVISTAR INTERNATIONAL TRANSPORTATION
CORPORATION
TRUCK ASSEMBLY FACILITY
SPRINGFIELD, OHIO
OHD 049 654 120**

FINAL REPORT

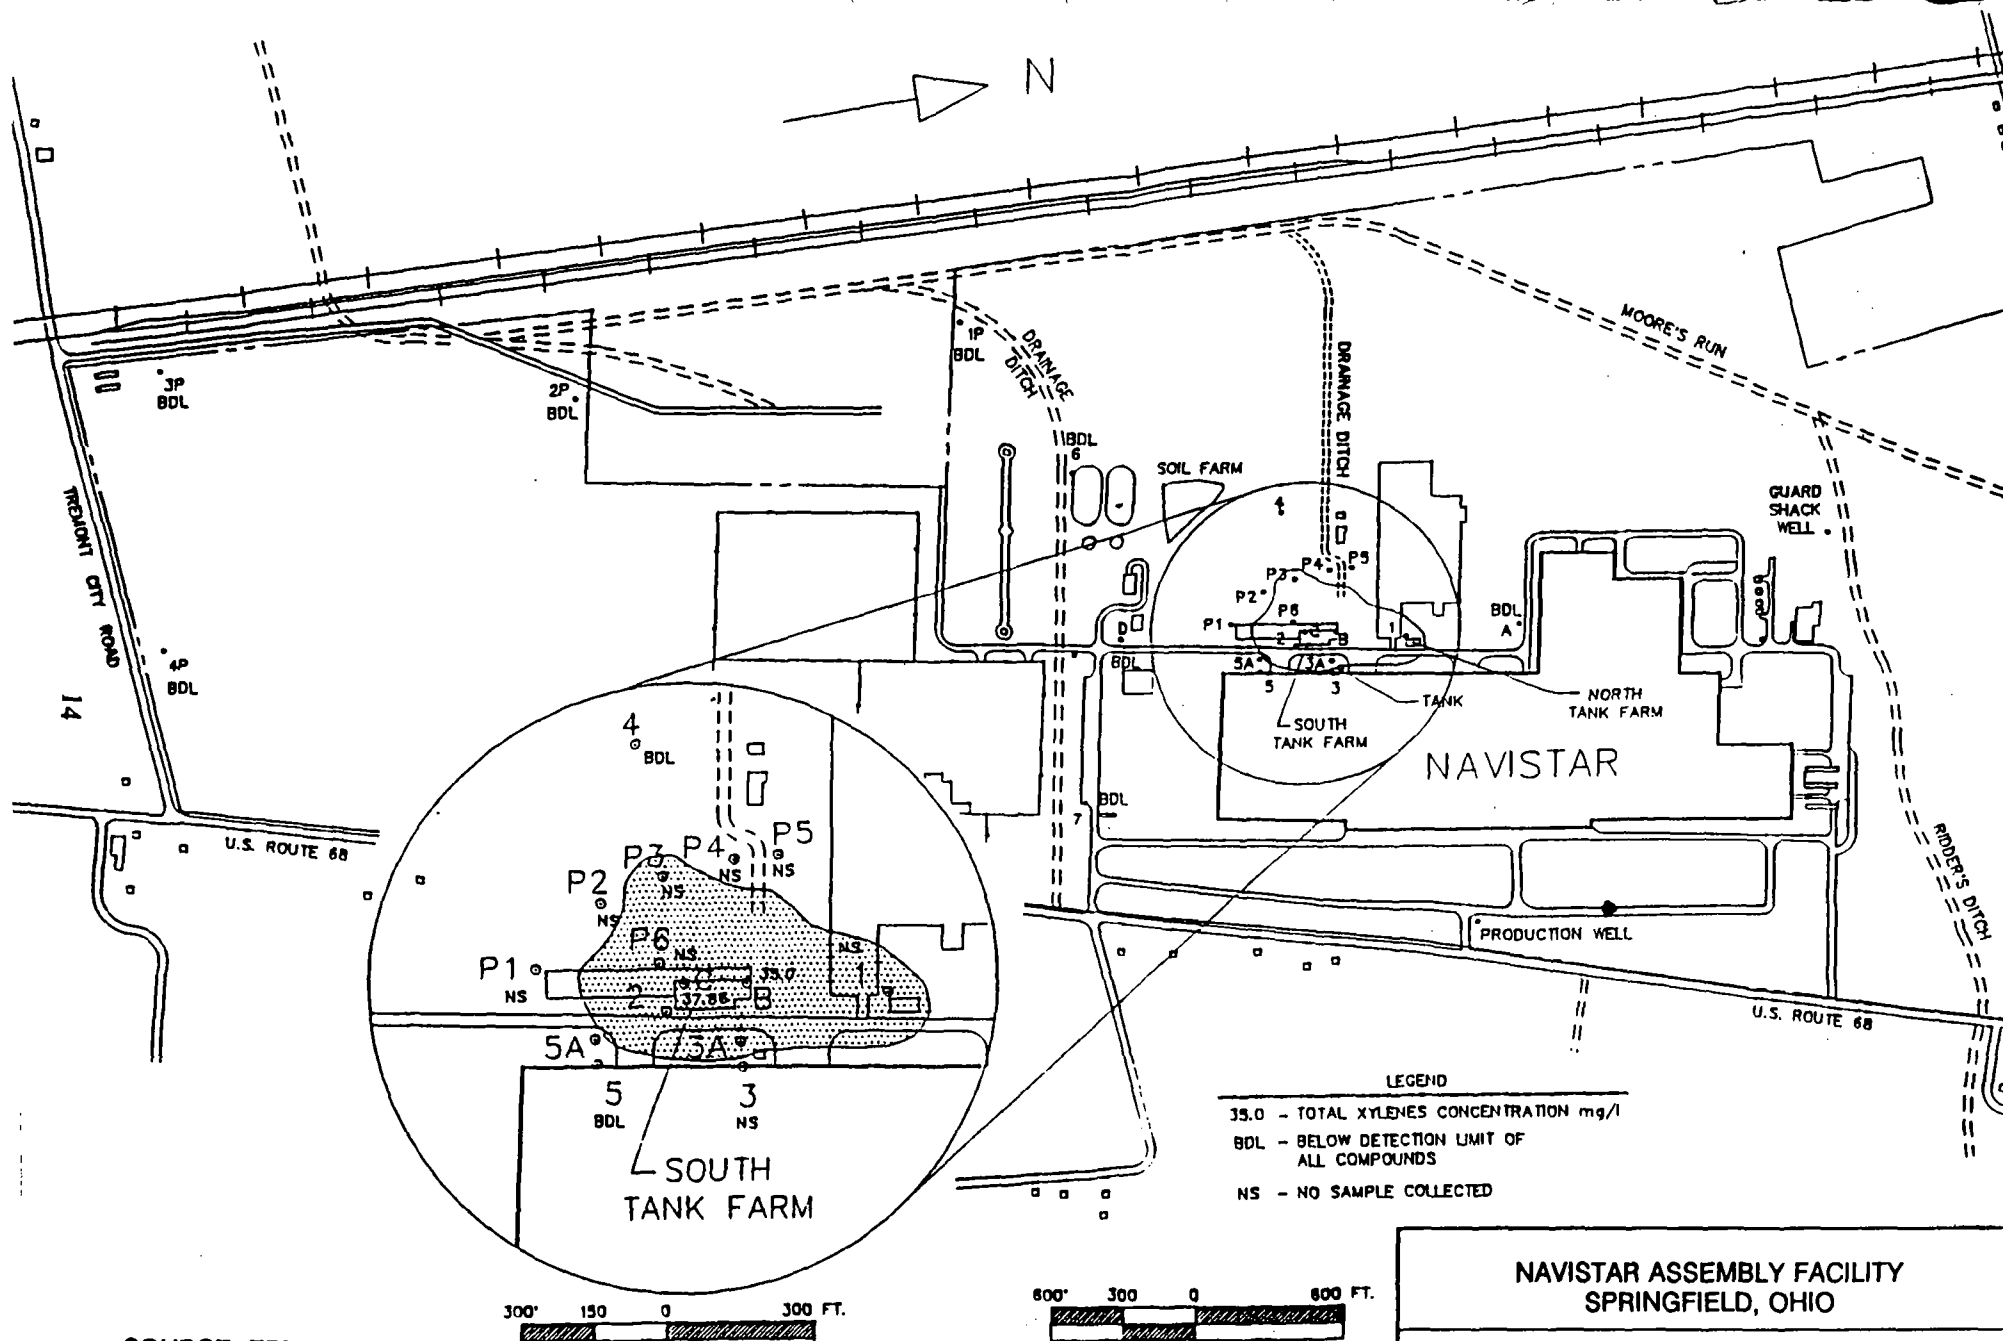
Figure 3 shows the extent of ground-water contamination at Navistar, as determined by the sampling in April 1989. For unknown reasons, not all wells at the site were sampled; therefore, a more conclusive identification of contaminant sources, presence, and migration patterns is not available.

35.0 - TOTAL XYLENES CONCENTRATION mg/l

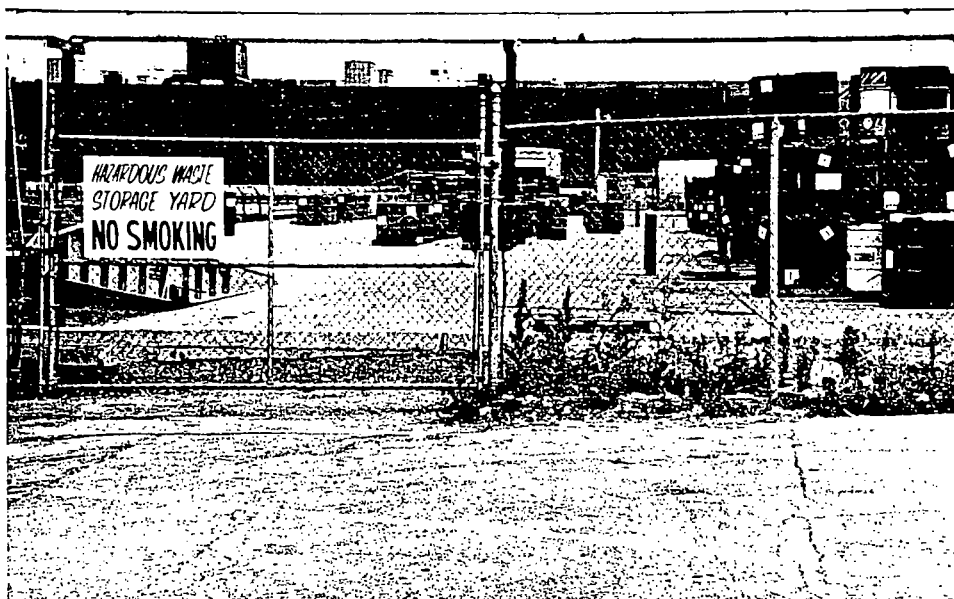
Unit Description: The Hazardous Waste Storage Area, located just west of the Navistar main building, is used for less than 90-day storage of *drummed waste. the area is concrete, uncovered, and measures about 40 feet by 100 feet.* The area is surrounded by a concrete berm and a 6-foot, steel, chain-link fence that is kept locked except during waste transfers (see Photograph Nos. 1 and 2).

Observations: The hazardous waste container storage unit appeared to be in sound condition during the VSI. PRC observed no evidence of release.

Photograph No. 1
 Orientation: North
 Description: The Hazardous Waste Storage Area

Location: SWMU 1
 Date: 6/13/91

Recommendations: No further action is recommended at this time.

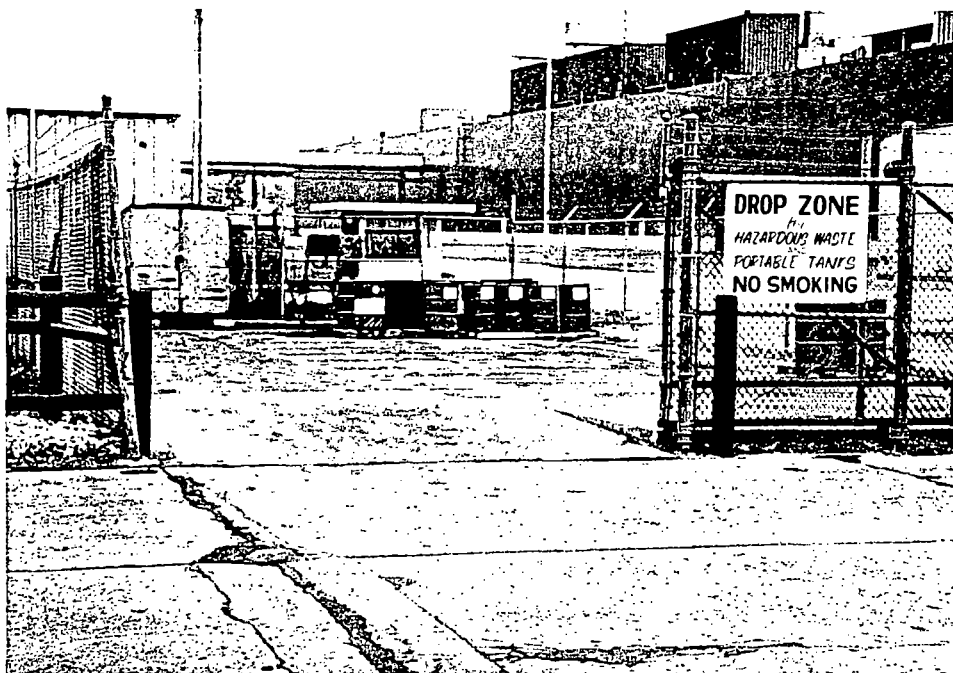
Photograph No. 2
 Orientation: West
 Description: The drop zone for the Hazardous Waste Storage Area

Location: SWMU 1
 Date: 6/13/91

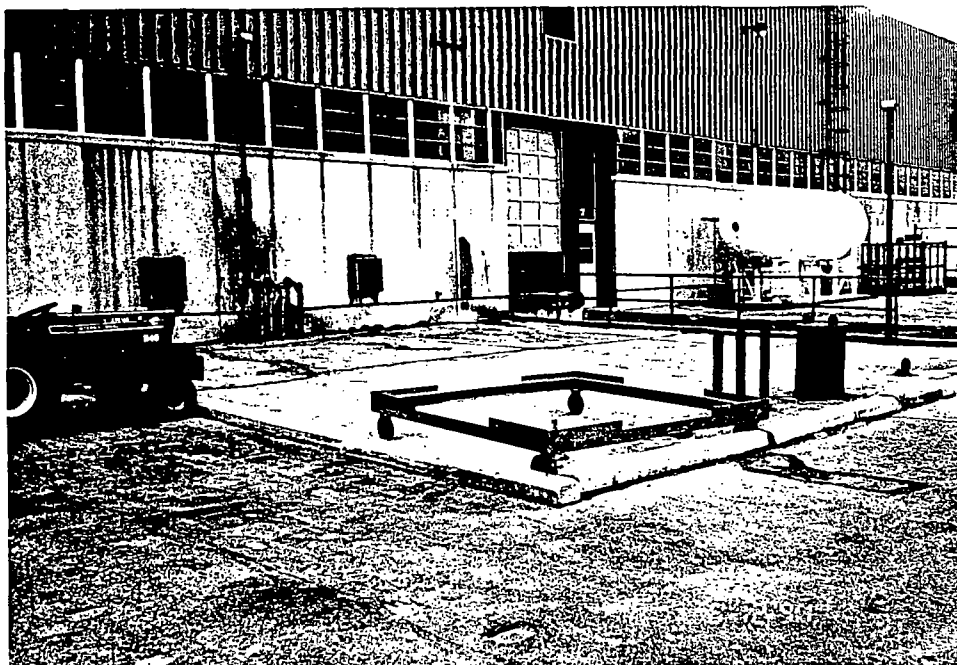
Photograph No. 3

Orientation: Southeast

Location: SWMU 2

Date: 6/13/91

Recommendations: PRC recommends a review of the results of the RI/FS being performed at the site. Once a review is complete, further action may be required.

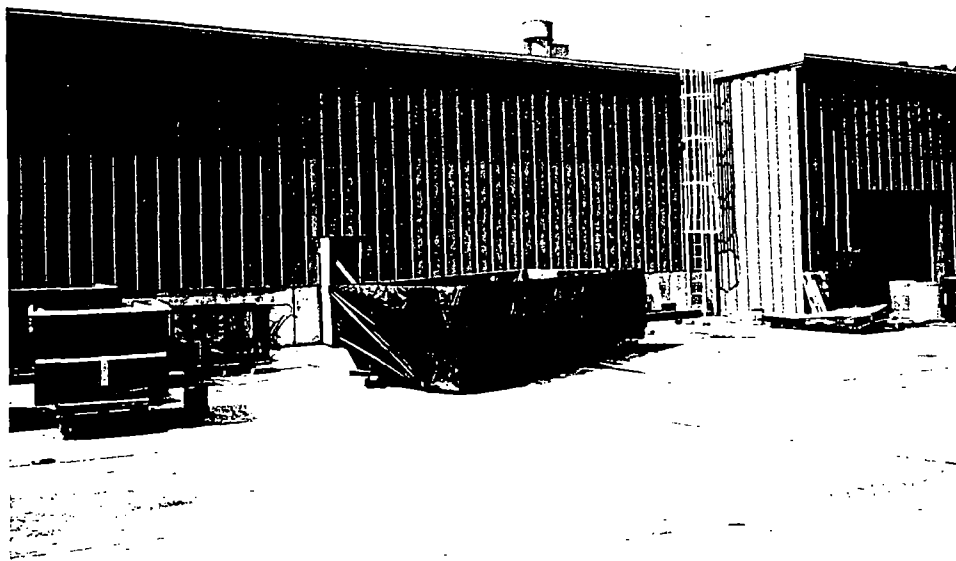
Photograph No. 4

Observations: During the VSI, the rolloff was in sound condition and no spilled material was noted.

Conclusions: The Sludge Rolloff is made of steel, kept covered and staged on concrete. *During the VSI, no spilled material or stains were noted near the unit. The potential for release via environmental media is summarized below.*

Orientation: Southwest

Location: SWMU 3

Date: 6/13/91

Recommendations: No further action is recommended at this time.

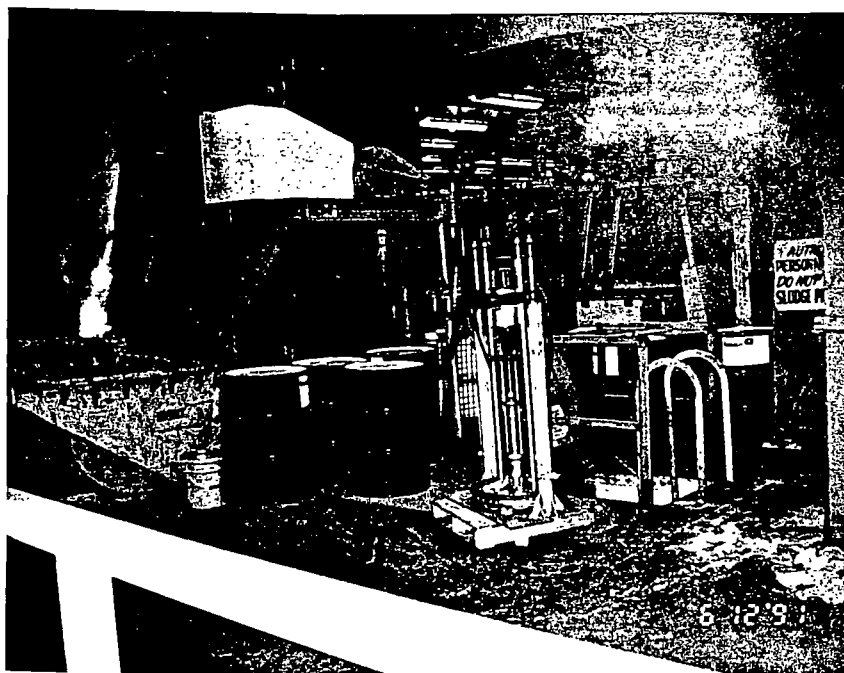
Unit Description: Navistar uses 300-gallon, stainless steel totes and 55-gallon drums for satellite accumulation of waste material. The totes are used in the finishing building for collection of wastes resulting from cleaning procedures. Until late 1991, totes were taken to the South Tank Farm (SWMU 2) and emptied. Totes are currently taken to the Bulk Tank Farm (SWMU 7). Full 55-gallon drums are taken to the Hazardous Waste Storage Area (SWMU 1) for 90-day accumulation (see Photograph No. 5).

Photograph No. 5
 Orientation: Southwest
 Description: Shown at the left is a tote used for sludge accumulation.

Location: SWMU 4
 Date: 6/13/91

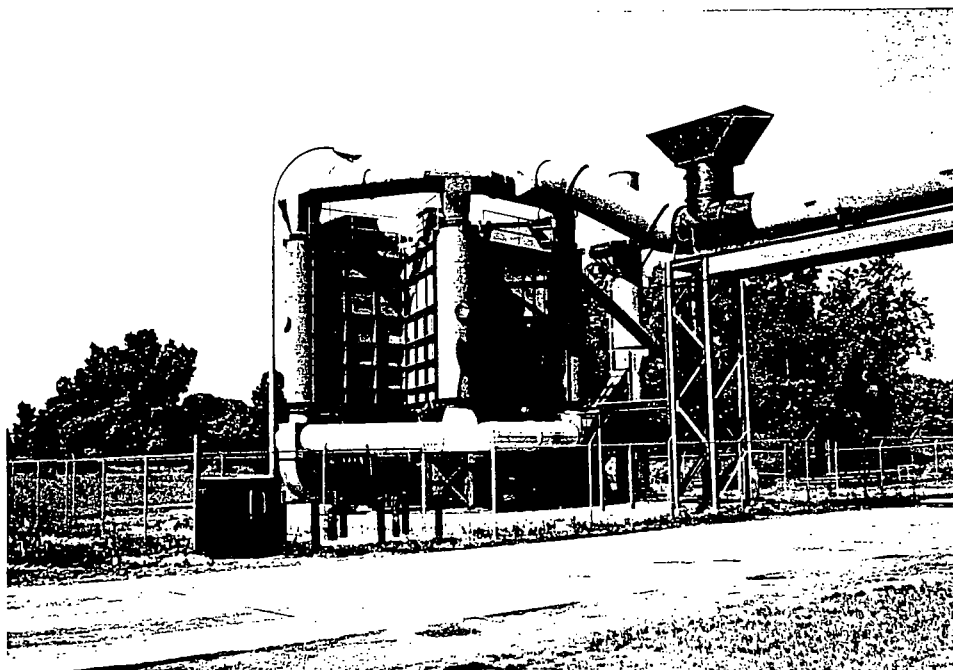
Release Controls:	The incinerator is a modern unit and is monitored continually for destruction of VOCs.
History of Documented Releases:	No releases from this unit have been documented.
Observations:	The incinerator appeared to be in sound condition during the VSI.

Photograph No. 6
 Orientation: Southwest
 Description: The Navistar VOC incinerator.

Location: SWMU 5
 Date: 6/13/91

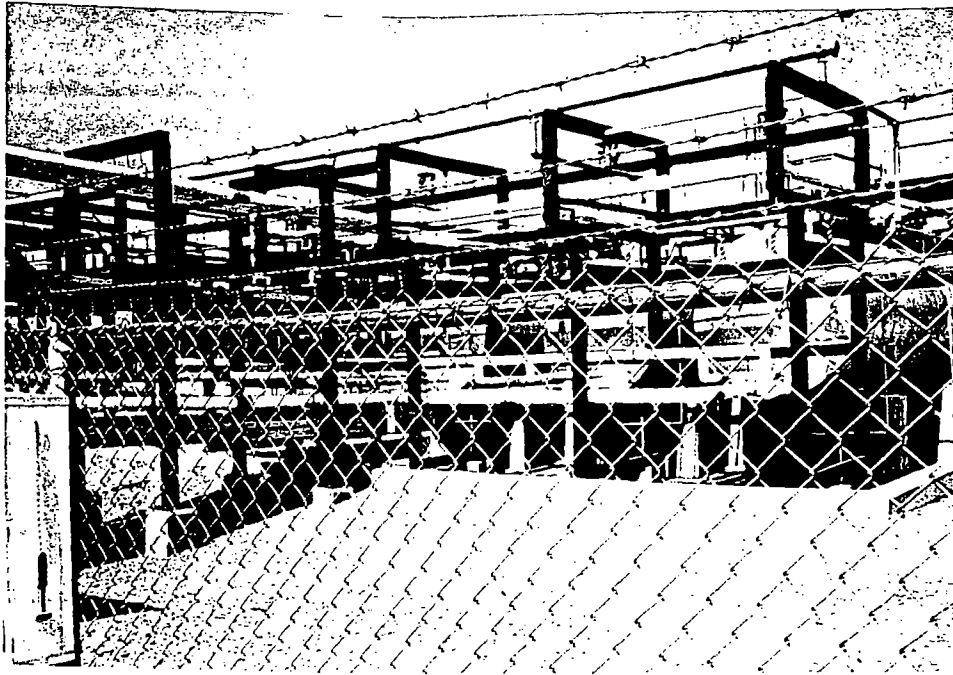
Photograph No. 7
 Orientation: West
 Description: The Bulk Tank Farm; note the containment system.

Location: SWMU 7
 Date: 6/13/91

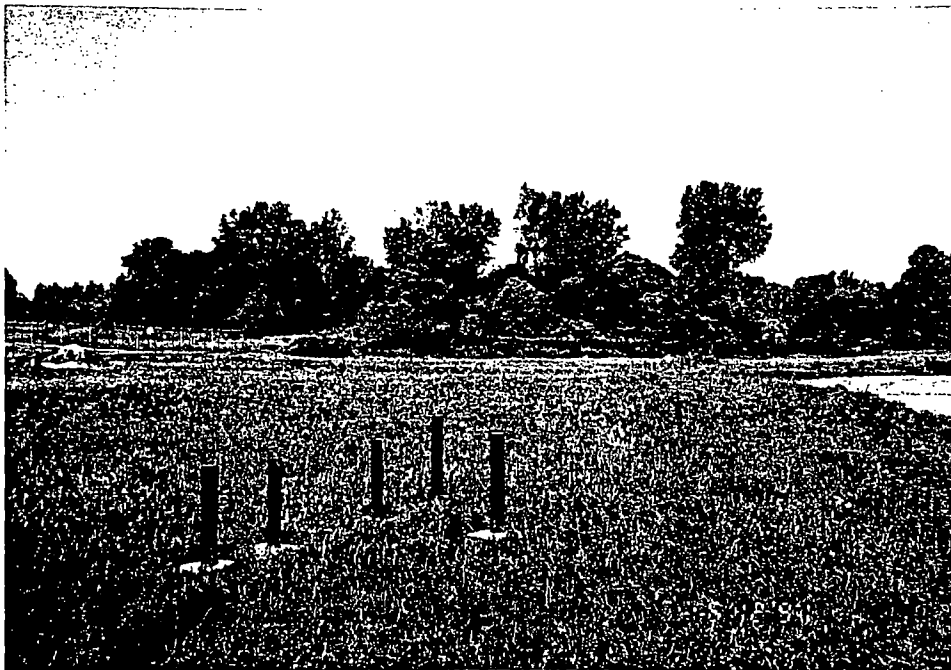
Photograph No. 8
 Orientation: West
 Description: The Waste Pile Area is in the background. Two sets of monitoring well clusters can be seen.

Location: SWMU 8
 Date: 6/13/91

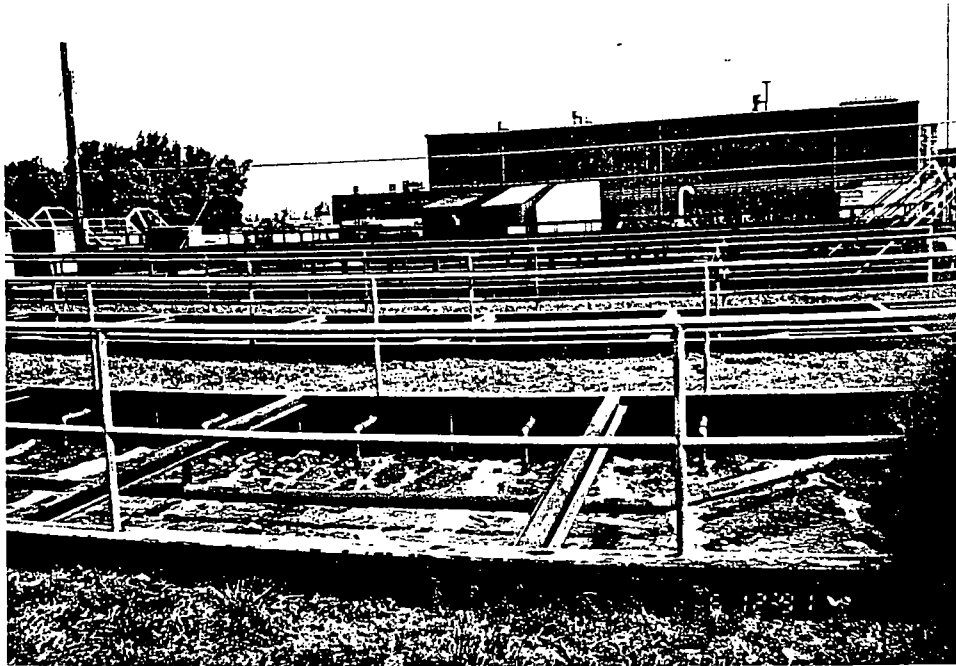
Photograph No. 9

Date of Startup:	The unit was constructed in 1966.
Date of Closure:	The unit is currently operating.
Wastes Managed:	The unit processes sanitary wastewater, industrial wastewater, and E-coat wastewater.
Release Controls:	The holding tanks at the facility are inspected regularly by Navistar. Holding capacities provide adequate retention during treatment system interruptions.
History of Documented Releases:	Navistar has violated its NPDES permit limitations numerous times over the years.
Observations:	The unit appeared to be in sound condition during the VSI.

Ground Water: Low. During the VSI, the Wastewater Treatment Plant tanks appeared to be in sound condition.

Orientation: North

Location: SWMU 9

Date: 6/13/91

Recommendations: PRC recommends that Navistar's wastewater plant effluent discharge be periodically sampled on an unannounced basis.

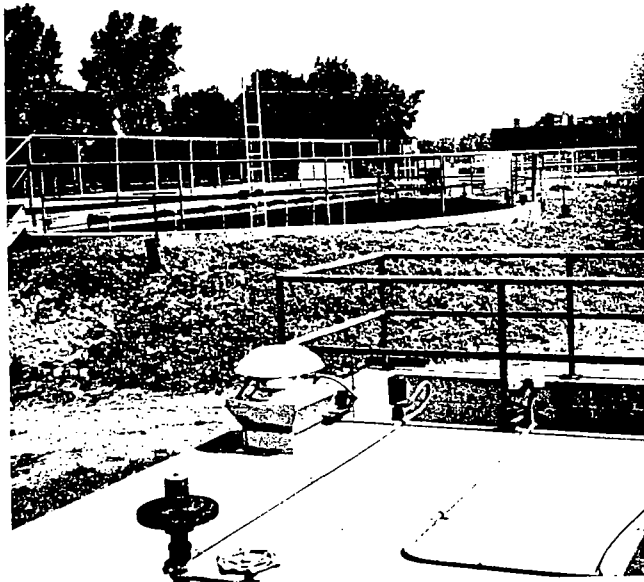
Photograph No. 10

Orientation: North

Location: SWMU 9

Date: 6/13/91

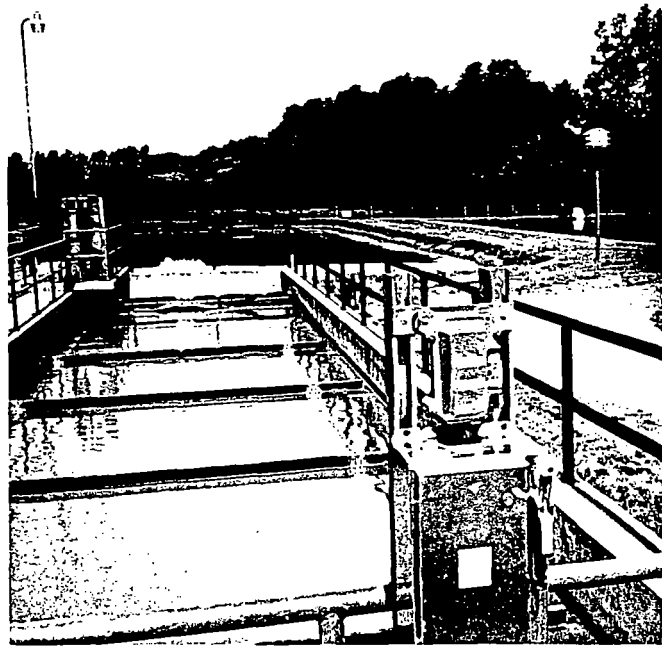
Photograph No. 11

Orientation: West
